**APPENDIX 2.5 - ROAD SAFETY AUDIT (RSA) FOR SECTIONS 2-5 OF THE STRATEGIC
TRAFFIC MANAGEMENT PLAN (STMP) FOR MID WALES WIND FARMS**

MID WALES WIND FARMS SECTIONS 2-5

PROPOSED HIGHWAY WORKS TO FACILITATE THE MOVEMENT OF ABNORMAL INDIVISIBLE LOADS ARRANGEMENT

Stage 1 Road Safety Audit

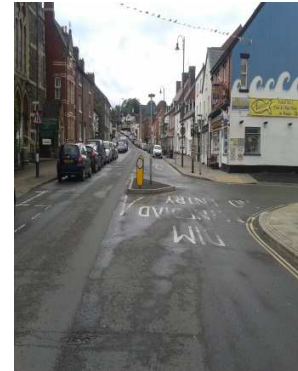
3.2.1 LOCATION: High Street, Welshpool

SUMMARY: New traffic island may restrict convoy

Since the drawing was produced a new traffic management layout has been implemented in the centre of Welshpool. A new traffic island has been introduced at the junction of High Street and Jehu Road. The combination of the new island and on-street parking may impede the movement of the convoy and increase the risk of conflicts with other road users.

RECOMMENDATION

Establish if the convoy can negotiate safely past the traffic island if the on-street parking is controlled. Alternatively, review the route through Welshpool to establish if there is another road for the convoy to use.
