# LLANBRYNMAIR WIND FARM

Supplementary Environmental Information February 2014

Volume II - Main Document, Supporting Appendices and Supporting Figures

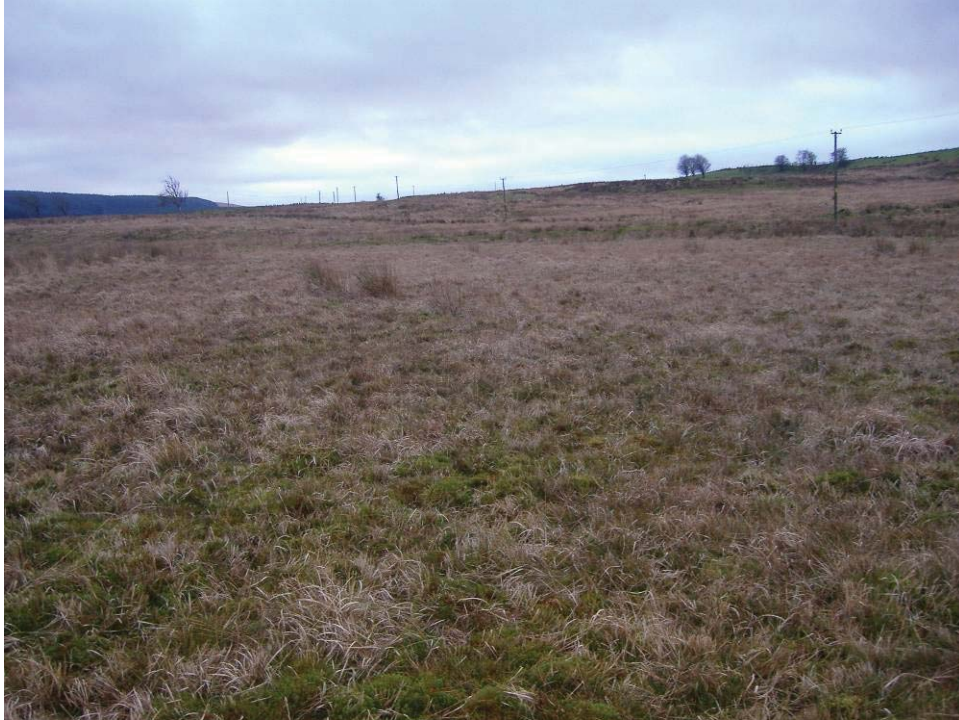
Photo 1: Main 'peat body' supporting M17 vegetation (photo taken from current route of bypass)

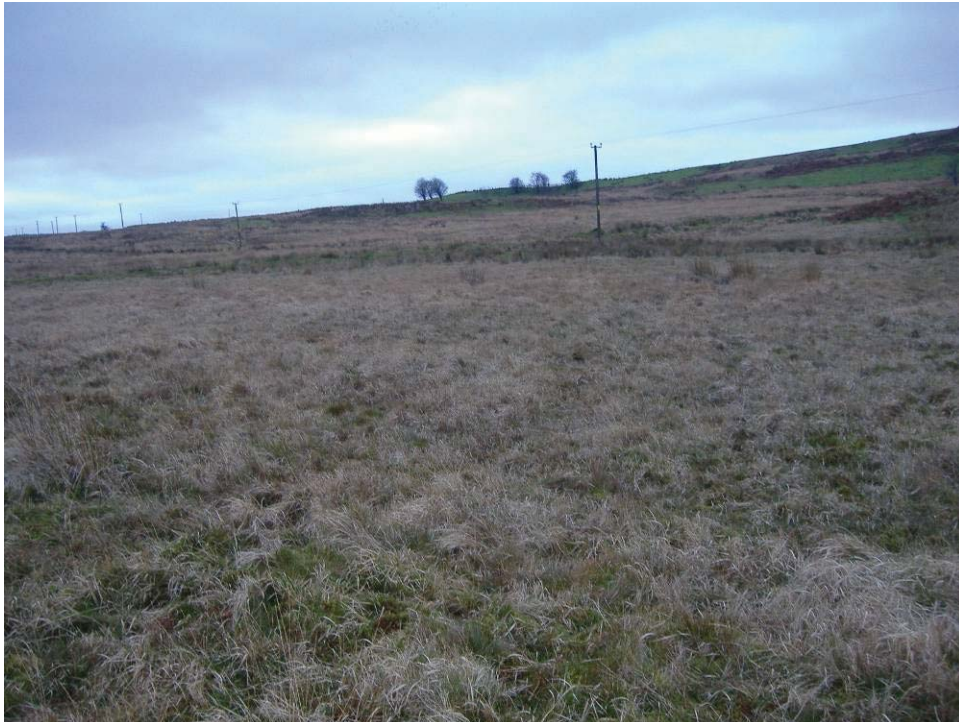
Photo 2: Showing main M17 - type vegetation

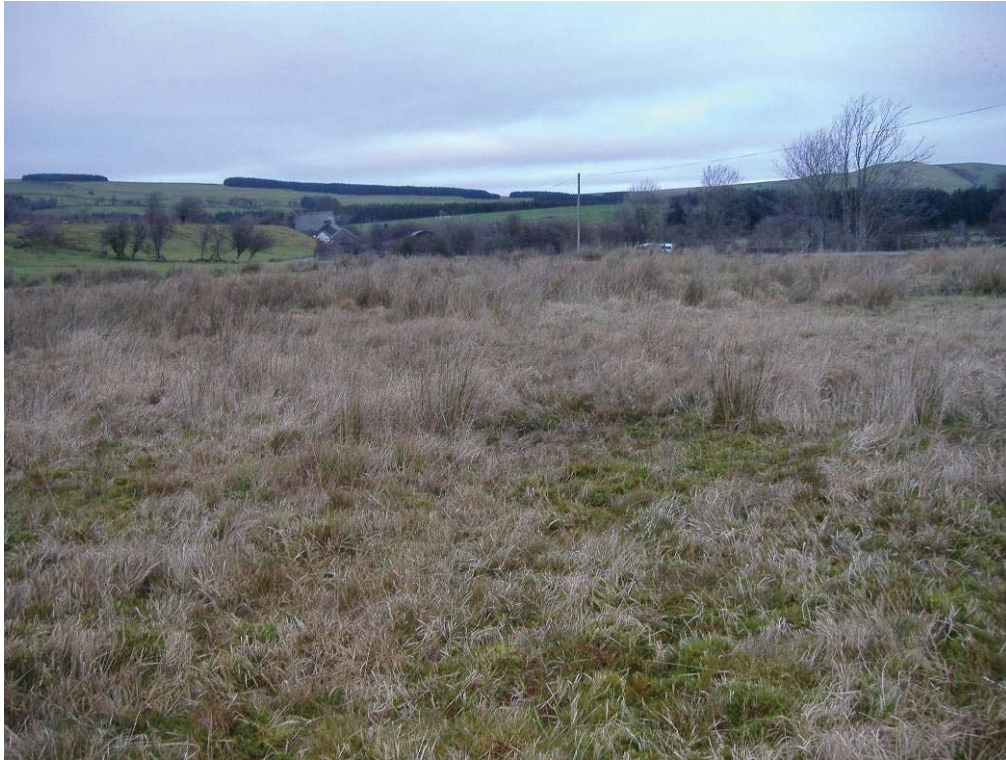
Photo 3: M25 '*Eriophorum vaginatum* variant' vegetation to north east of U6/M17 vegetation (note obvious transition, with greater *Molinia caerulea* dominance)

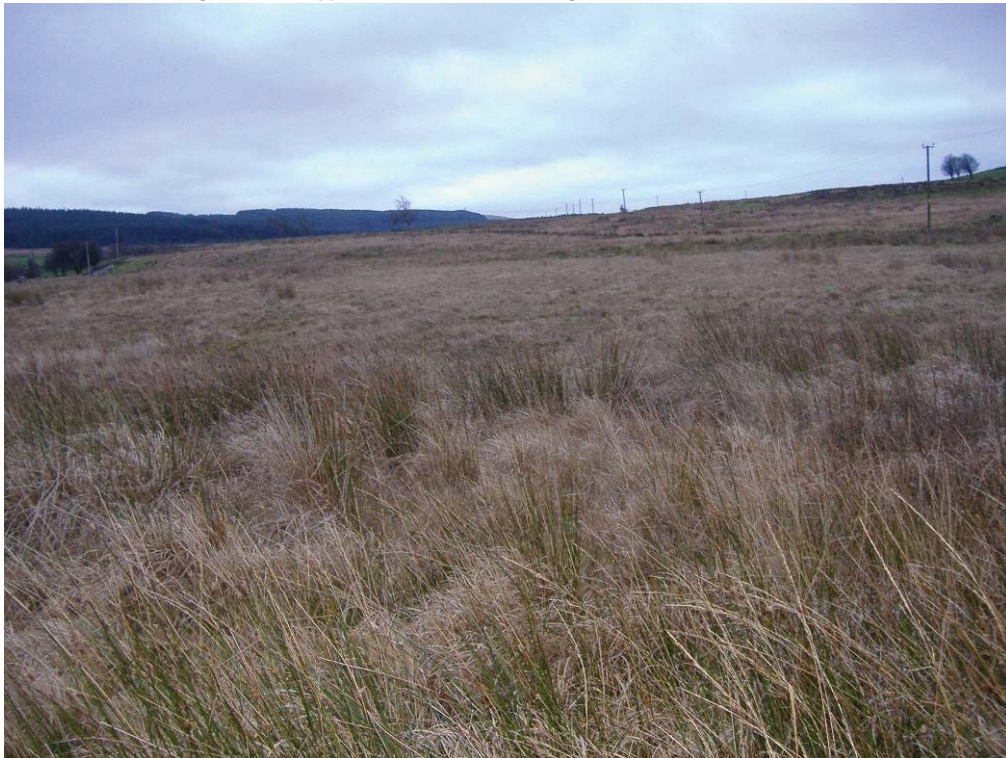
Photo 4: Showing *Juncus effusus*-dominated vegetation to the north east (M6c)

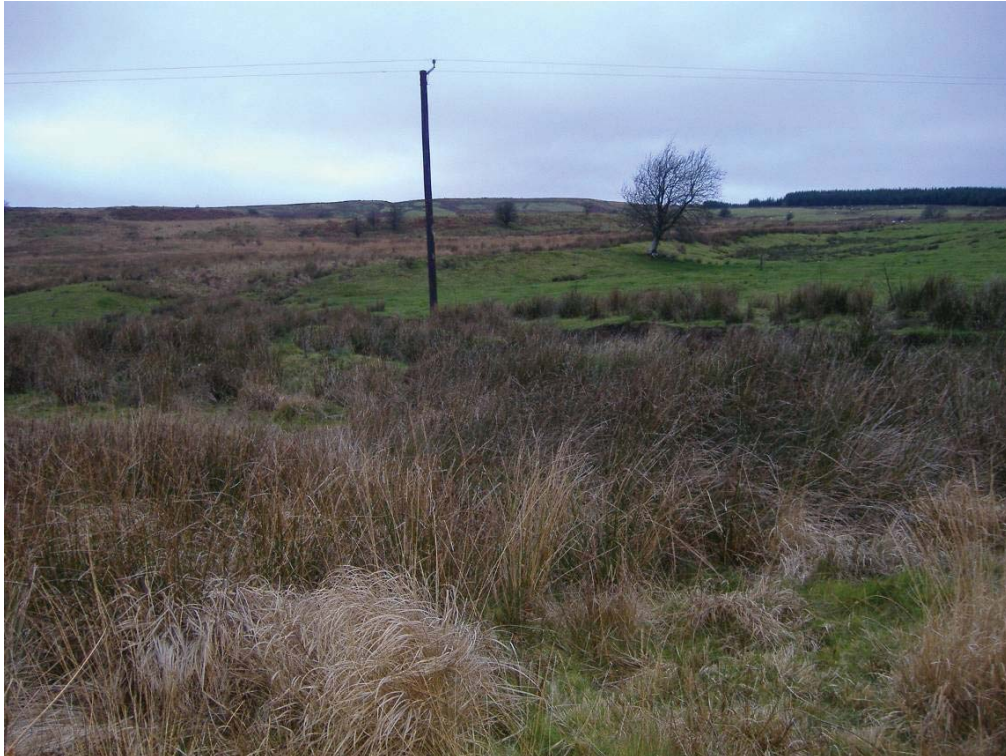
Photo 5: *Juncus effusus*-dominated vegetation with MG6 grassland beyond

Further to the north east, the vegetation changes again. A ditch supporting abundant *Sphagnum denticulatum* and *Juncus effusus*, with occasional to frequent *Molinia caerulea* and occasional *Glyceria fluitans* is best categorised as M6c *Carex echinata* - *Sphagnum fallax* / *Sphagnum denticulatum* mire *Juncus effusus* sub-community, though there is also some *Juncus acutiflorus* here, suggesting referral to the M6d sub-community. The vegetation to the north west of this point is similar, and dominated by *Juncus effusus*. This is species-poor M6 vegetation and is of lesser ecological value. A photograph (photo 4) of this area is provided. The vegetation becomes drier here, between the *Juncus effusus* tussocks. The vegetation in the next field compartment is species-poor MG6 grassland, as shown in Photo 5.

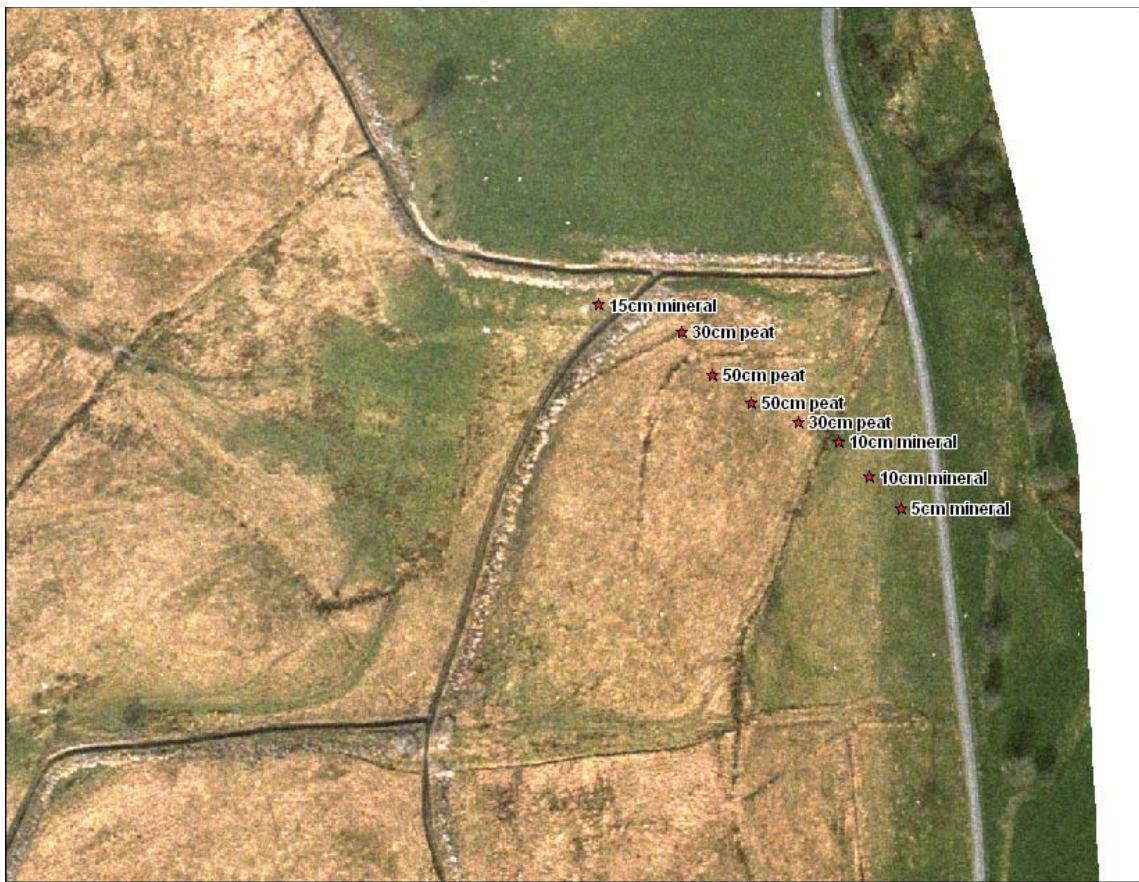
Figure 2: Soil and peat probes

There will be an impact on peat from the bypass in this location. The central section is on 50cm peat (just within the CCW / NRW classification of deep peat). On the basis of the two depths of 30cm and two depths of 50cm recorded within the red line of the bypass alignment (a length of 50m in the peat), a bypass width of 6m and peat depth of 0.5m, the development will disturb between 100-200 m<sup>3</sup> of peat.

- 2.2.8 No peat was found following probing of areas of proposed works between Sections 2.4 and 2.8. Probes across the route of the Neinthirion bypass found depths of between 30 and 50 cm. Full results are given in **Appendix 2.2**.
- 2.2.9 The hedges and verges are considered typical of roadside habitats found across Montgomeryshire.

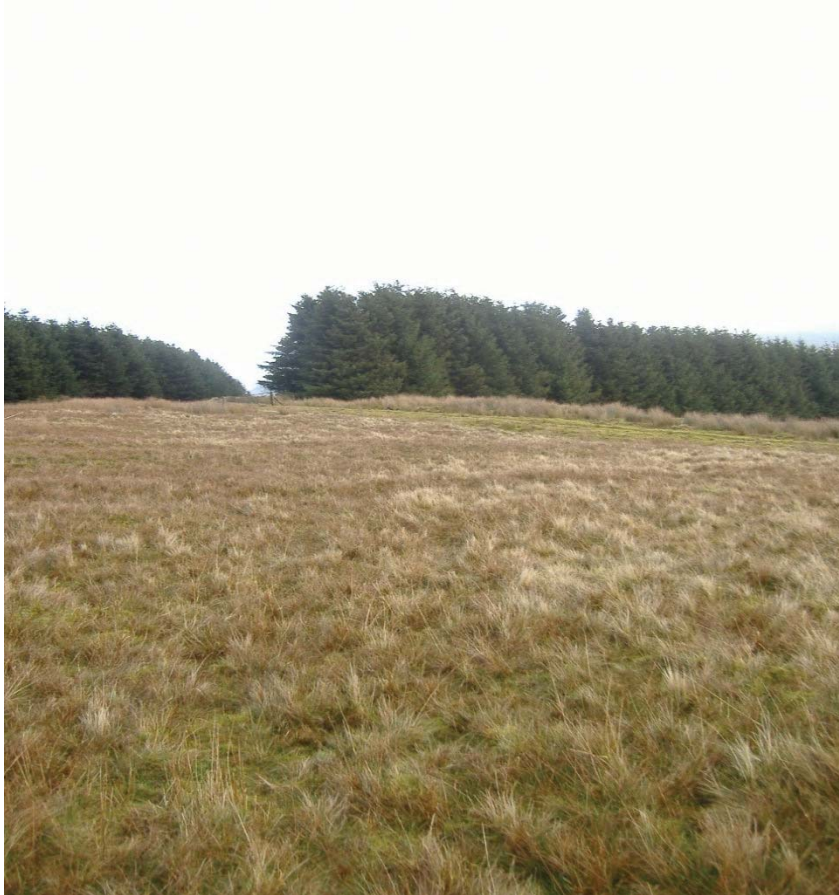
Photo 1: Showing area of U5b/U6d grassland

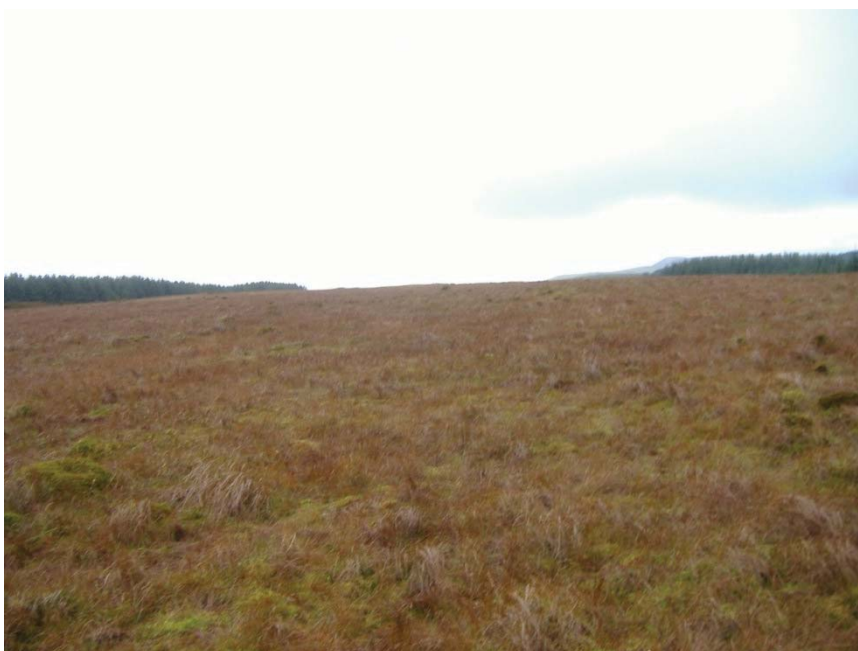
Photo 2: Showing area of M18 blanket bog

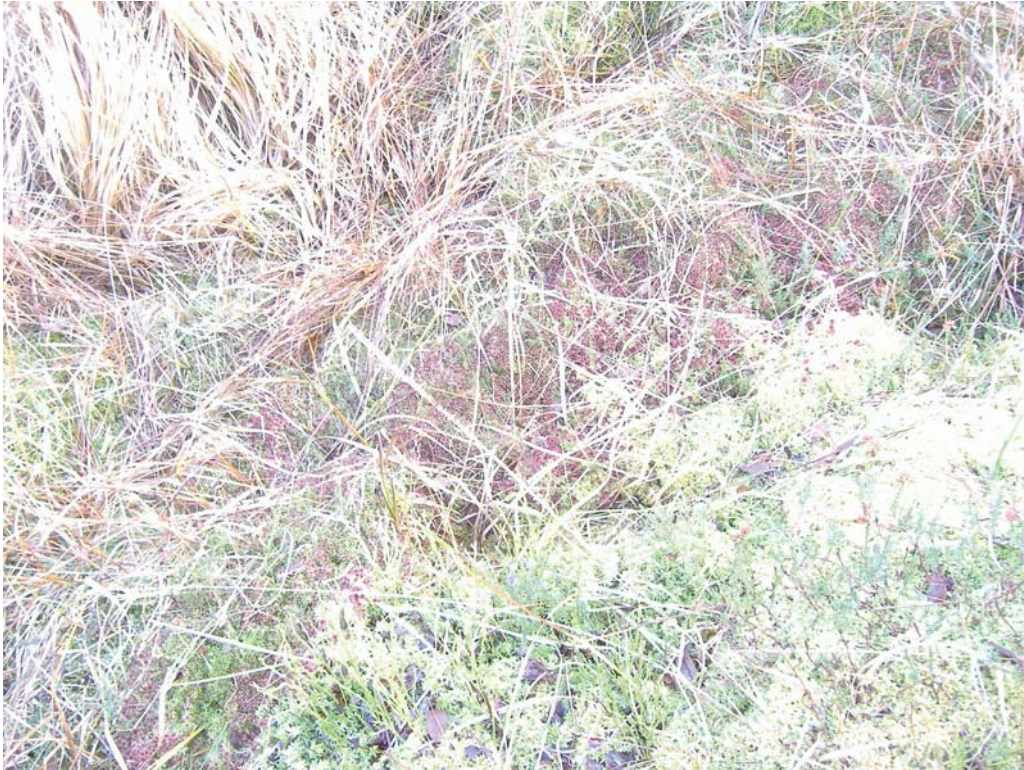
Photo 1 M17a sub- community

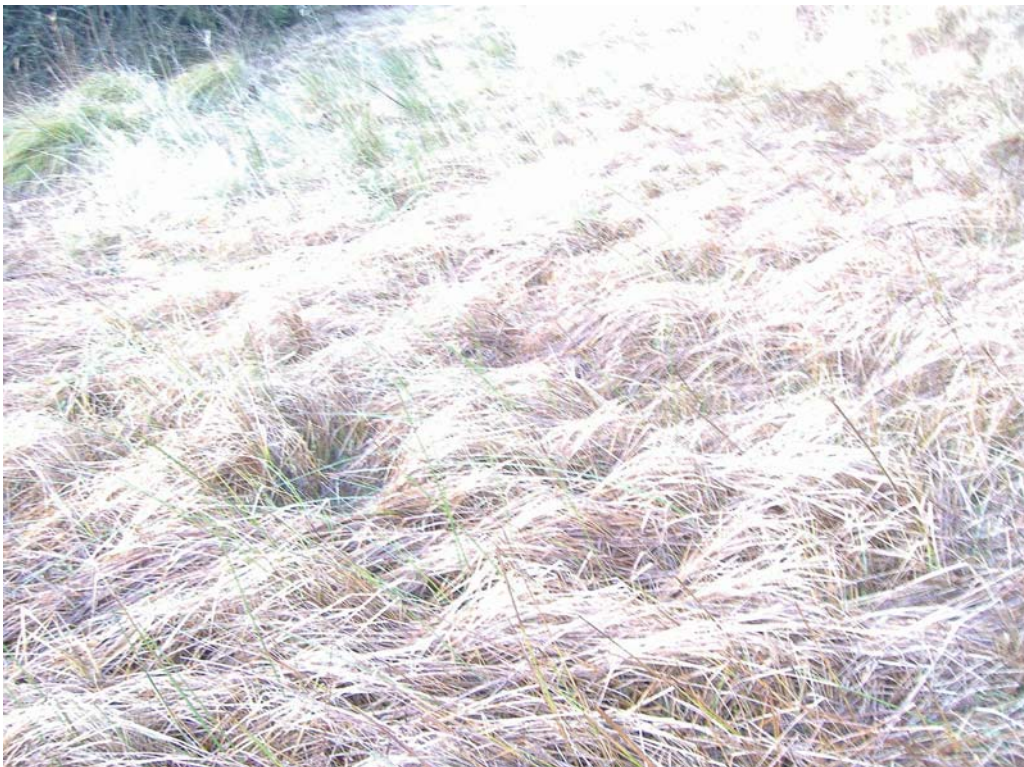
Photo 2 Photo 2 M6d sub- community

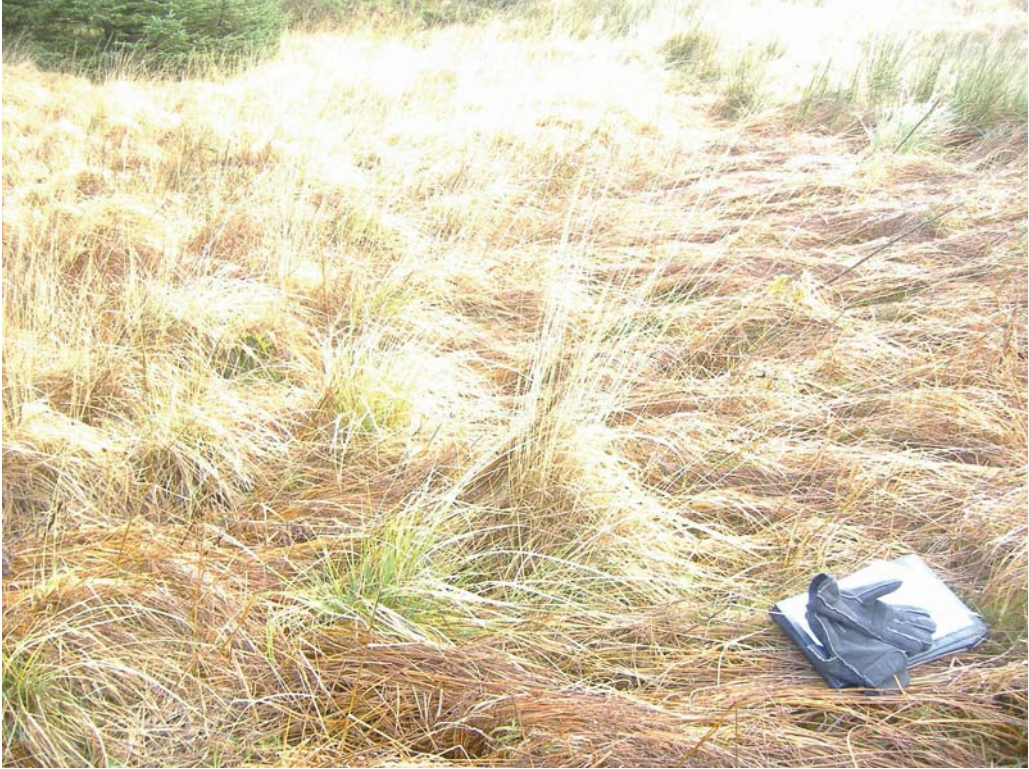
Photo 3: M23a sub-community

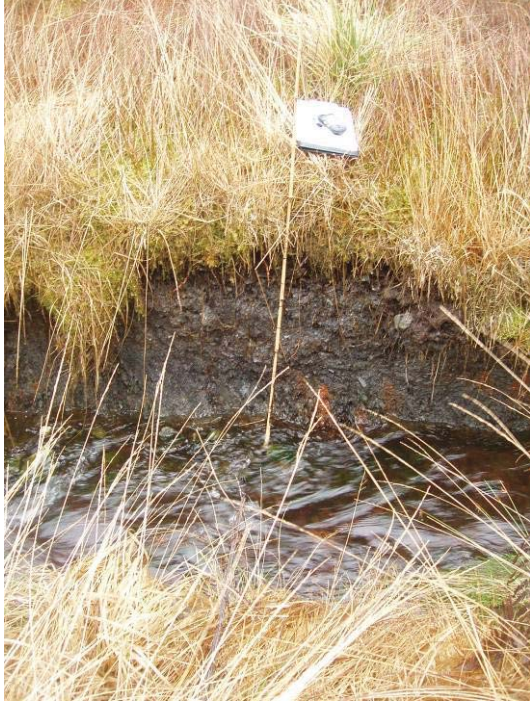
**Photo 1.** Nant Ffriddycastell watercourse at SH 96360 09200. Watercourse crossing No 23.

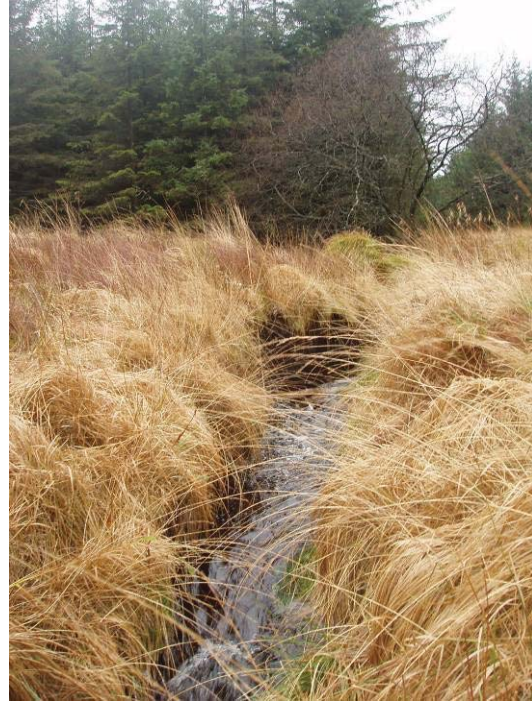
**Photo 2.** Looking upstream from SH 96360 09200

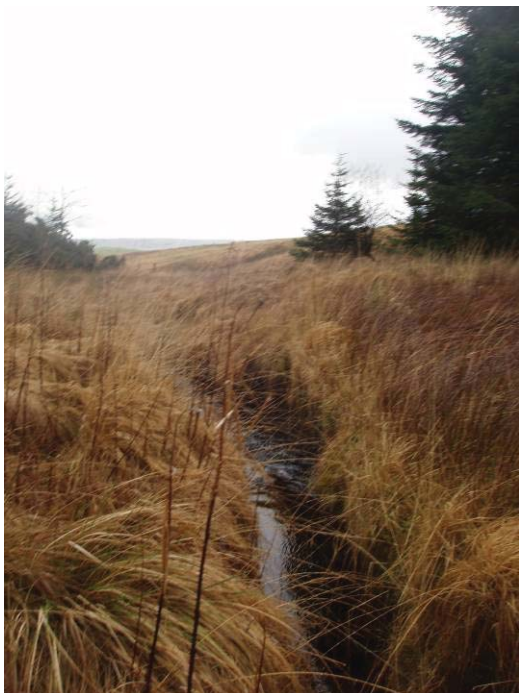
**Photo 3.** Looking downstream from SH 96360 09200
